13 Holland St. : Analysis of the Problems leading to a Claim Against the Cambridge City Council and a Refutation of the Claim.

Introduction

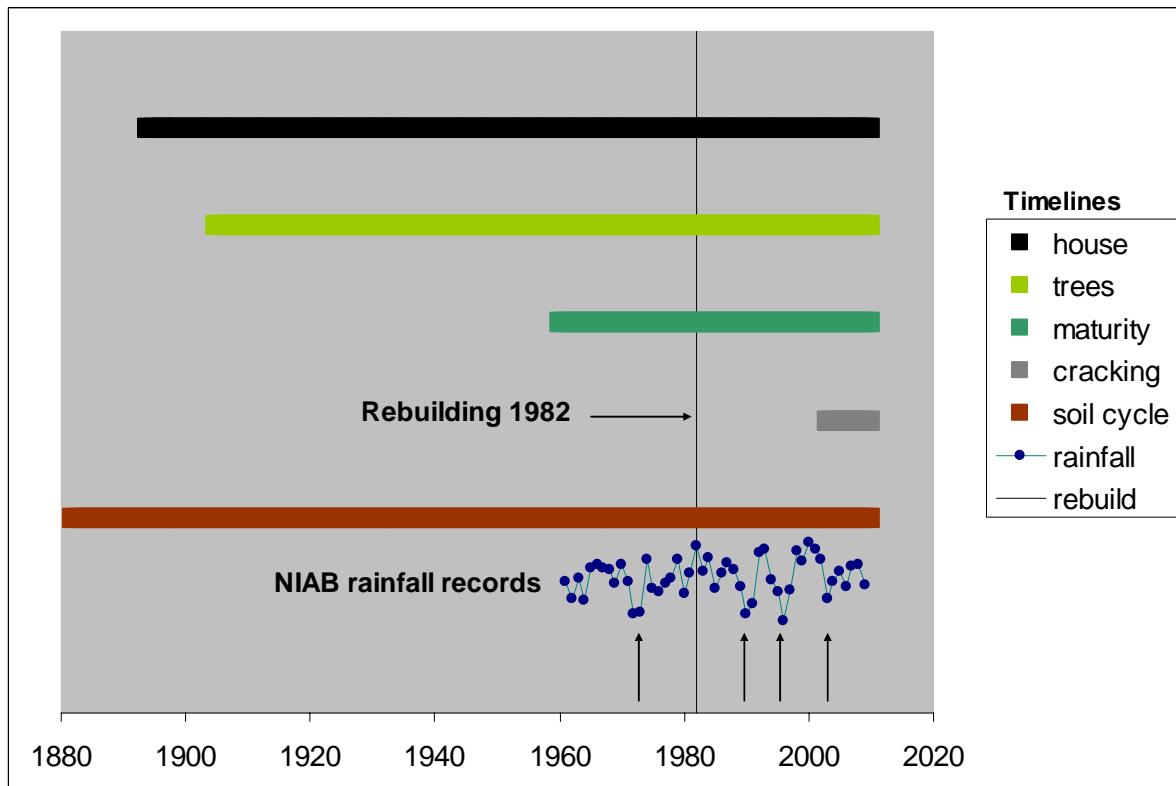
Figure 1

The house was built in 1894 and the trees planted in 1905. The trees would have reached maturity in the 1960s as can be seen by a timeline diagram in Fig.1. The cracking is limited to 2003 onwards but the trees were mature 40 years previously. The annual soil cycle of clay shrinkage and swelling has certainly been a feature of the soil since it was formed as a deposit before Cambridge existed and is caused by summer drying followed by winter rains. The cracking to the house did start in a somewhat dry year, but after five wetter than average years (the rainfall data is from NIAB, a Met. Office registering station site on the Huntingdon Road approaching Girton College, so the data is truly local). More to the point, there were far drier years previously,

in 1972-73, 1990 and 1996 (see arrows), which produced no evident cracking. We shall argue below that the damage is cumulative strain subsequent to changes in the structure of the house after rebuilding from 1980 onwards, perhaps accelerated by drying in 2003. Common sense dictates that something in the years closer to 2003 must explain the relatively sudden cracking of the property¹.

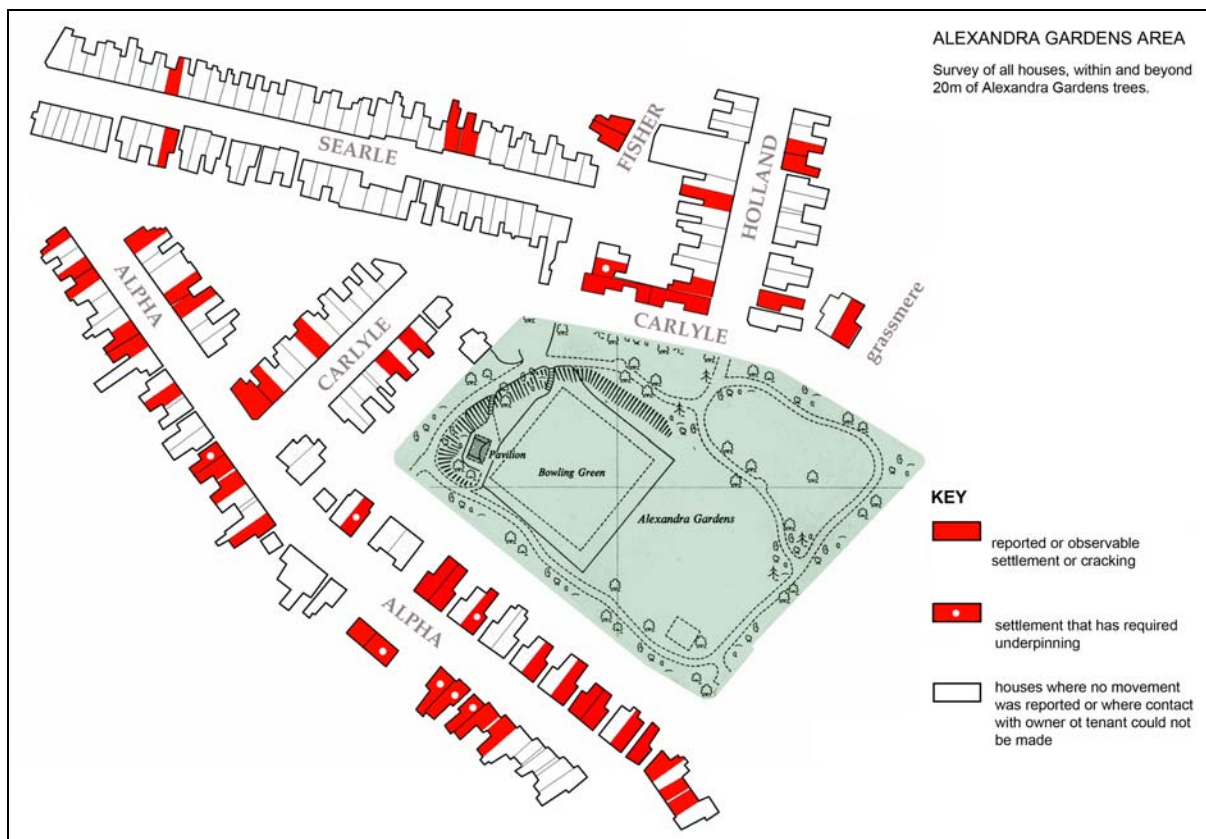
Figure 2

Our survey of the properties around the area (the park and several nearby streets) has shown widespread settlement and cracking with a few buildings underpinned – the majority of the latter are not near the park or thought to be caused by adjacent mature trees (Fig.2) . Clay soil does move annually whether near trees or not, responding to the summer-winter cycle.

The distribution clearly shows that there is little correlation with proximity to trees. Many of the properties, built in the late 19th – early 20th century, have had extensions added to their backs over the years. The relevance of this latter finding will be evident from our analysis below.

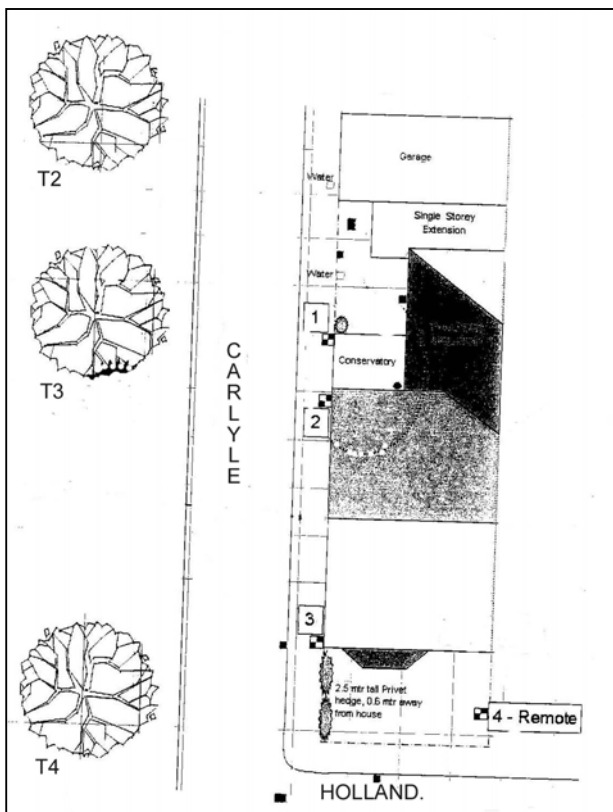
Examination of the three test boreholes (marked 1-3 in Fig.3) along the outer line of the house show two things with respect to the small roots found. First, the roots are weakly present. The middle borehole 2 adjacent to the nearest tree to the house chosen to be felled (T3) contained no roots at all. If there were an extensive root mat under the house such sporadic results would not be found. Second, the starch content of the roots, where found, was only moderate when at that sampling time (December) it should be high⁴. Trees store 80% or more of their carbohydrate reserves in root parenchyma and if healthy and vigorous would be expected to have a high starch titre.

These facts show that root growth under the pavement running along the house side nearest the trees is weak⁶ and could not possibly be responsible for sudden cracking in 2003. The root zone would have been fully developed in these mature trees for *at least* 40 years.

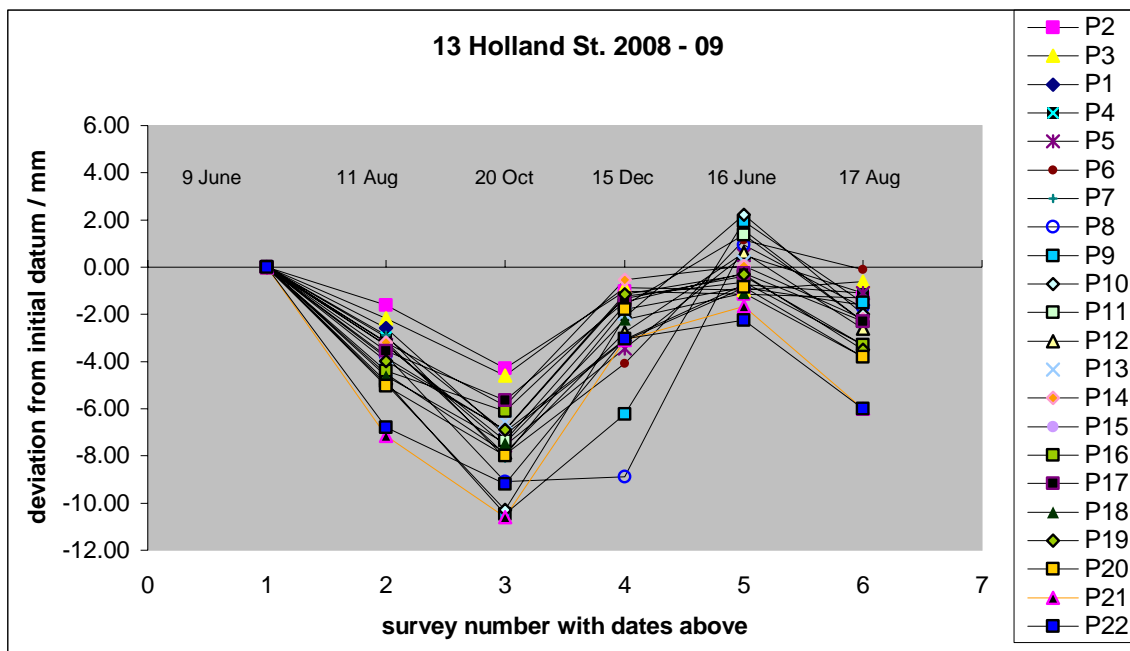
data for the whole year, released 2010,⁸ is plotted in Fig.4 it is clear that there is no net subsidence but the usual expected annual fall and rise of the ground.

Figure 4. Plot of all the data points for the whole year Jun08 – Jun09

The data shows no initial deviation at zero time (by definition) but it can be seen that the fall of level during the drying phase of the year is reversed during the wetter half. When the points at each date are averaged, as in Fig.5 below, it can be seen that the house as a whole returns to the same level. Given this movement, which most houses in the area have to cope with, why has the house only recently cracked rather than half a century ago ?

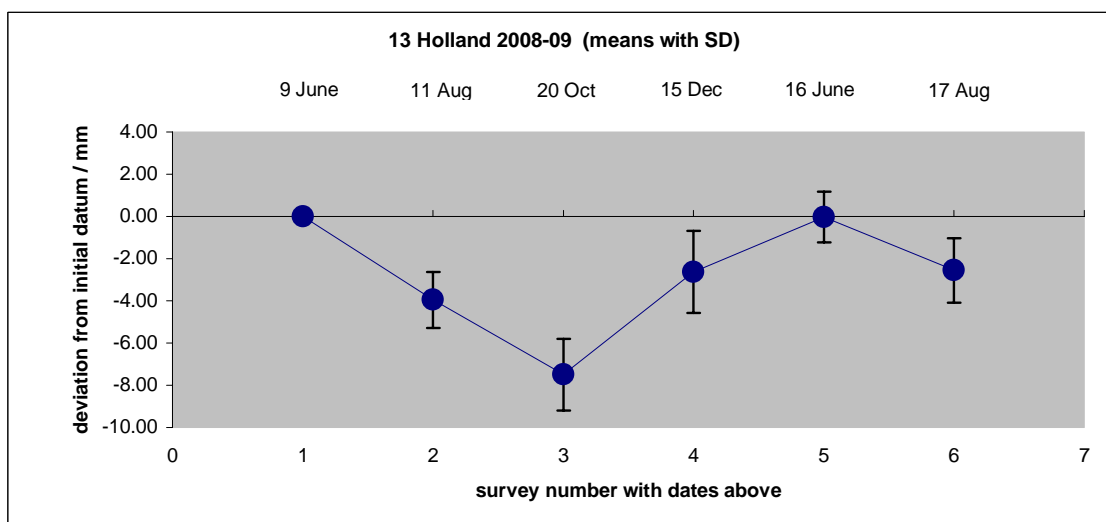
Figure 5. Averages of all points at different dates.

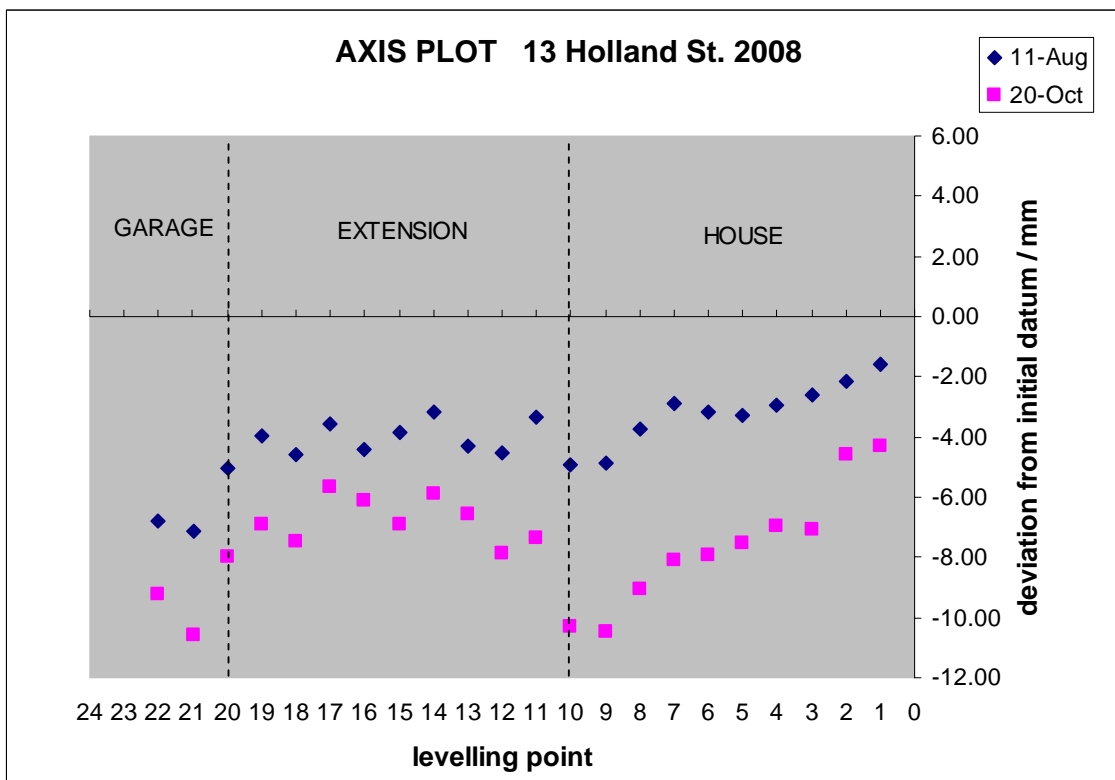
What is really required is a plot showing the movements at different times *as a function of position*. This is shown in Fig.6 below and from this one can deduce the relative movements of parts of a building. When this is done at two dates, 11 August and 20 October 2008, i.e. the two sets of measurements showing a fall in level of the structures, the following picture emerges :

The movements around the wall of the building of clearly show that it is moving up and down in three articulated sections, the house, the middle extended section and the garage. (1) At the points 1-10 the house is flexing downwards to its lowest point on the corner; (2) the middle section from points 11-19 abruptly shows less fall spanning the middle section, and finally (3) from 19 onwards the garage plunges again. The conservatory, a small separate building, is straddling two of the sections and is cracking as a result.

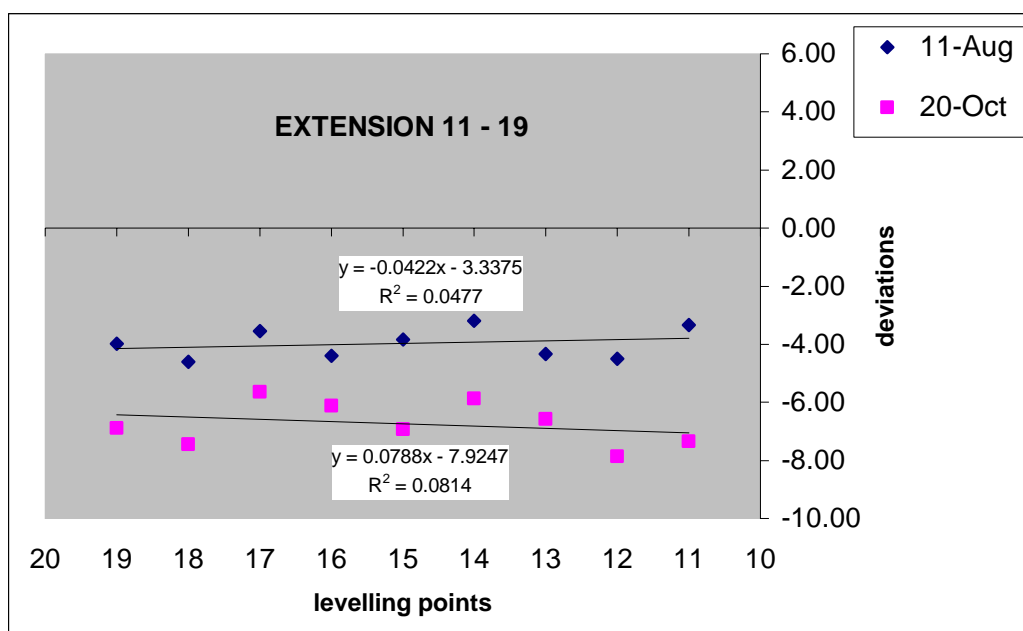
Figure 8

In Fig.8 below we analyse the level changes in the middle section (11-19) a further important fact emerges :

the linear regressions show that the slopes at the two different dates are 0.0422 and 0.0788 mm/point. As the points are roughly a metre apart along the walls this is less than 1/10th mm per metre. The extension is moving vertically like a flat horizontal plate. This is because the central extension section has foundations that are rigid over some considerable area and is probably locked in, horizontally by its brickwork, to the old back projection from which it was extended.

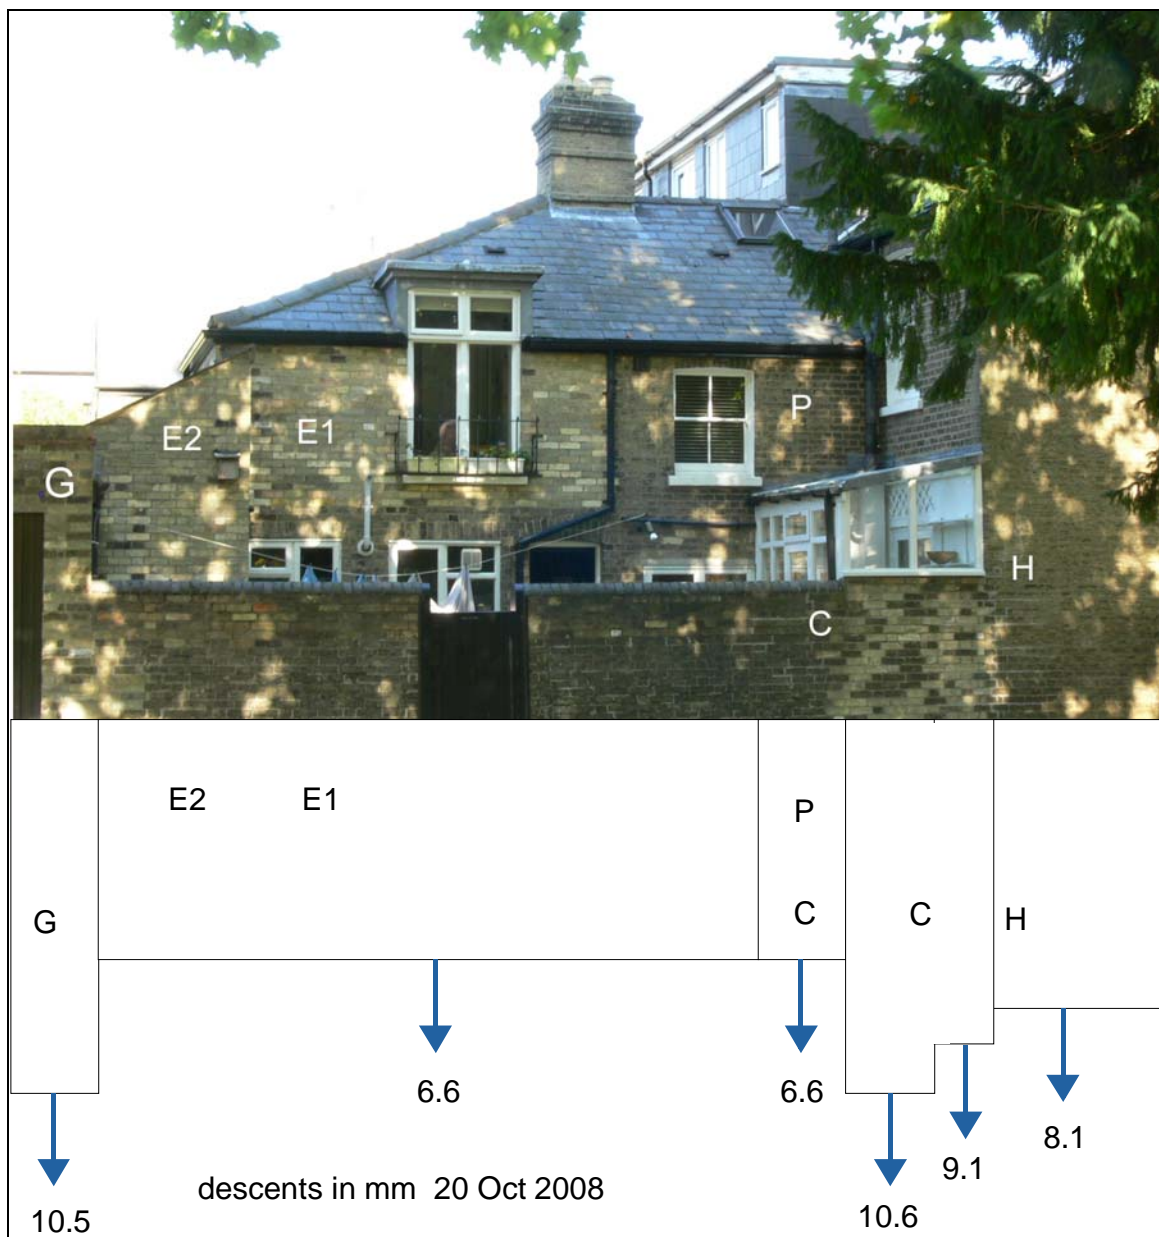
Shown in Figure 9 above is a picture of the house which should be compared with the levelling points diagram in Figure 7. The sections are labelled : H (end of house wall, rear left), C (conservatory), P (back projection to original house), E1 (new extension to projection), E2 (new

single storey extension) and G (garage). The junction between G and E2 occurs between the levelling points 19–20, whilst the two rightmost sections C and H span the points 7–10. The middle section which appears rigid represents the points 11–19.

Consequently the old house with back projection, which was adapting to the annual soil cycle for 100 years by gently flexing, has now found itself coupled to a rigid central section and can no longer flex. The poor conservatory wall is obviously being pulled apart between the old back projection and the gable wall. Cracking may also be taking place in the garage, where there is movement between it and the rigid central section but we have no data on this and the coupling between it and the extension E2 may be less tight and consequently it can move independently.

A cardinal point is the apparent angular distortion to which the brickwork has been subjected. Assuming the levelling points are spaced about a metre apart this is as great as 4mm i.e. $1/250$, a value that exceeds the accepted tolerance for brickwork and plaster¹⁰. This stress is occurring in the building where the damage is greatest (see below).

The result demonstrates a basic principle of building – that an extended structure should not be built on different foundations with differing mechanical properties unless separated by a full height movement joint. We emphasize that this is almost certainly the real and recent cause of the cracking in the house. The cracking pattern outside and within the house amply confirms this analysis. We show below in Figure 10 the distribution of 11 crackings (which may not be individual cracks but groups, referred to as ‘cracking’) either shown by the owner or described in a letter to insurers’ agents¹¹. They fall into three groups: (i) those located near the rear wall and the adjacent back projection (marked P in Figure 9 and the wall between P and H with the conservatory, C); (ii) the corner of the house and adjacent gable wall (H); and (iii) elsewhere, being apparently confined to the hall, an area which also runs to connect with the back. We would expect the major cracking area to be along the walls P to H, including the conservatory, and this is seen to be the case; (i) and (ii) combined account for 91% of the damage. This is to be expected if the building is made of structures on different foundations joined together by interlocking brickwork.

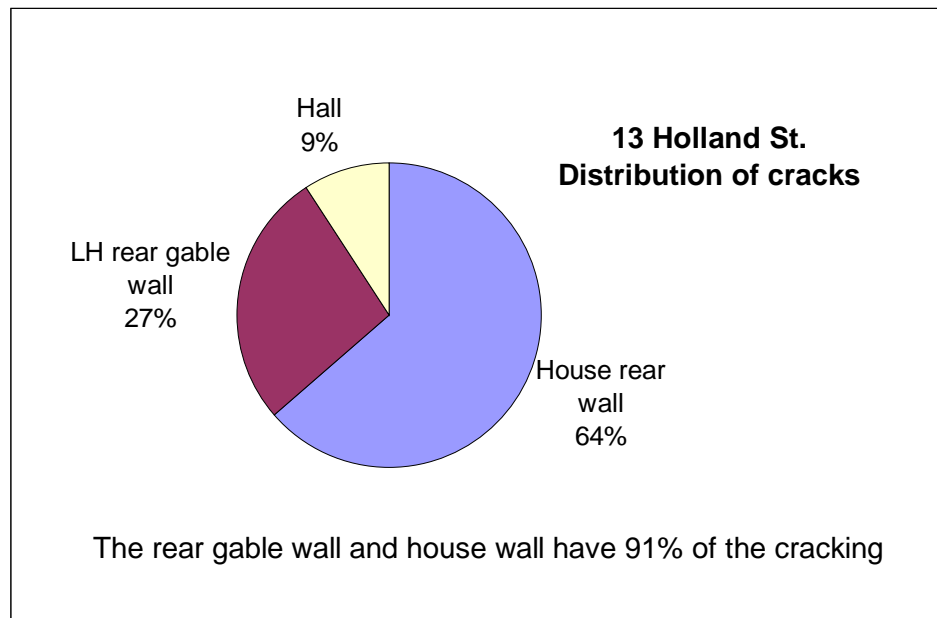
Figure 10 Analysis of the cracking

Cracks take time to develop. Lime mortar is a composite material of two phases, a hard granular one and a more fibrous one. Under cyclic loading, as occurs here annually, micro-cracks first develop and as the process repeats these are recruited along stress lines to ever larger cracks which finally appear¹². In addition, when a crack has started small loose granules, particularly below ground, can fill parts of the crack and prevent its re-closure after rehydration of the soil – a ratchet effect. The process rarely happens immediately but is time-dependent¹³. This would explain the delay between the rebuilding and the cracks first being noticed. In a dryer summer as occurred locally in 2003 (see Figure 1) the annual excursions of the subsoil would have been greater than normal and would certainly have accelerated the cracking.

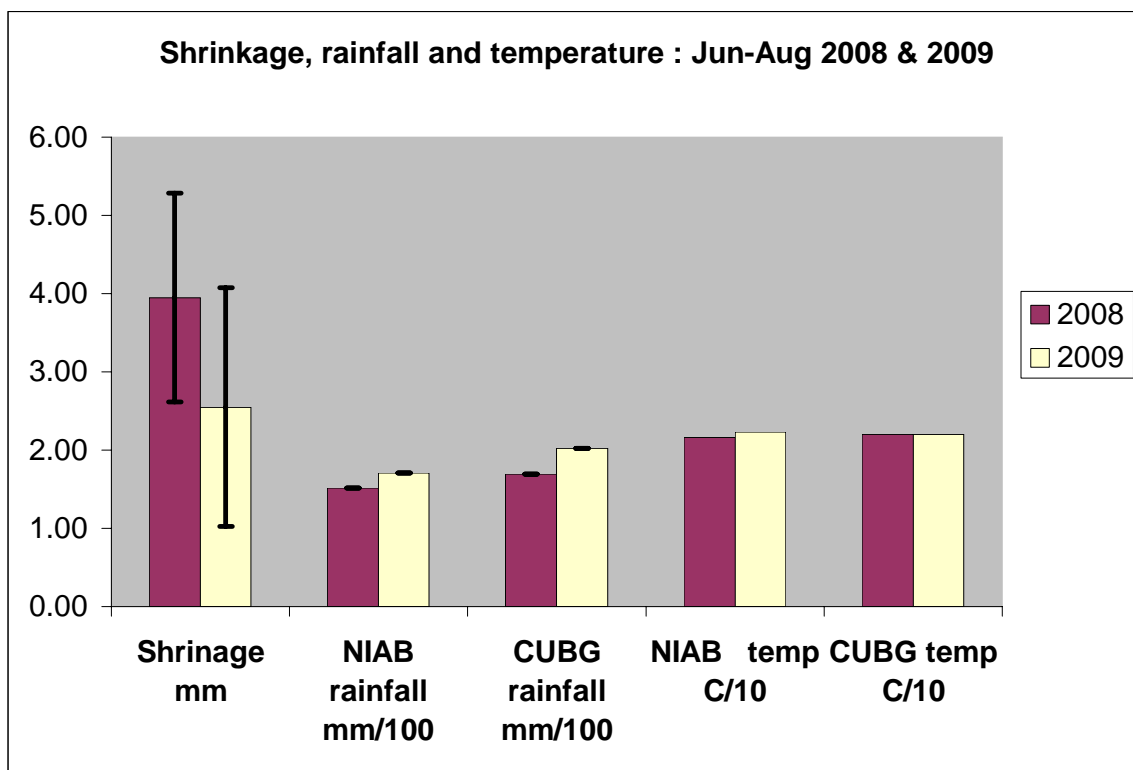
Second, annual records do indicate a drier 2009 in Cambridge but not for the period June-August. We are fortunate in having two Meteorological Recording stations here: NIAB (National Institute of Agricultural Botany CB3 0LE, 2 miles North of Alexandra Gardens) and CUBG (the Cambridge Botanic Garden CB2 1JE, 1.6 miles to the South) so we are closely spanned by these

two. The rainfall was higher in both stations for the period in question in 2009 v. 2008 (NIAB: 170/151 mm, CUBG: 202/169 mm) a difference of 13 – 20% for those three months.

Third, the temperatures, an important input to the dryness of any period, were virtually identical (22°C). Thus evapotranspiration, the major input to the soil drying, could not have increased in the period either. This collected data is shown in the Figure below.

Dr. Biddle’s reasoning cannot therefore be sustained. As a demonstration of the efficacy of pruning it obviously cannot be used, based on such slender data, to pollard these mature trees even if there were no other data indicating the obvious cause of recent damage.

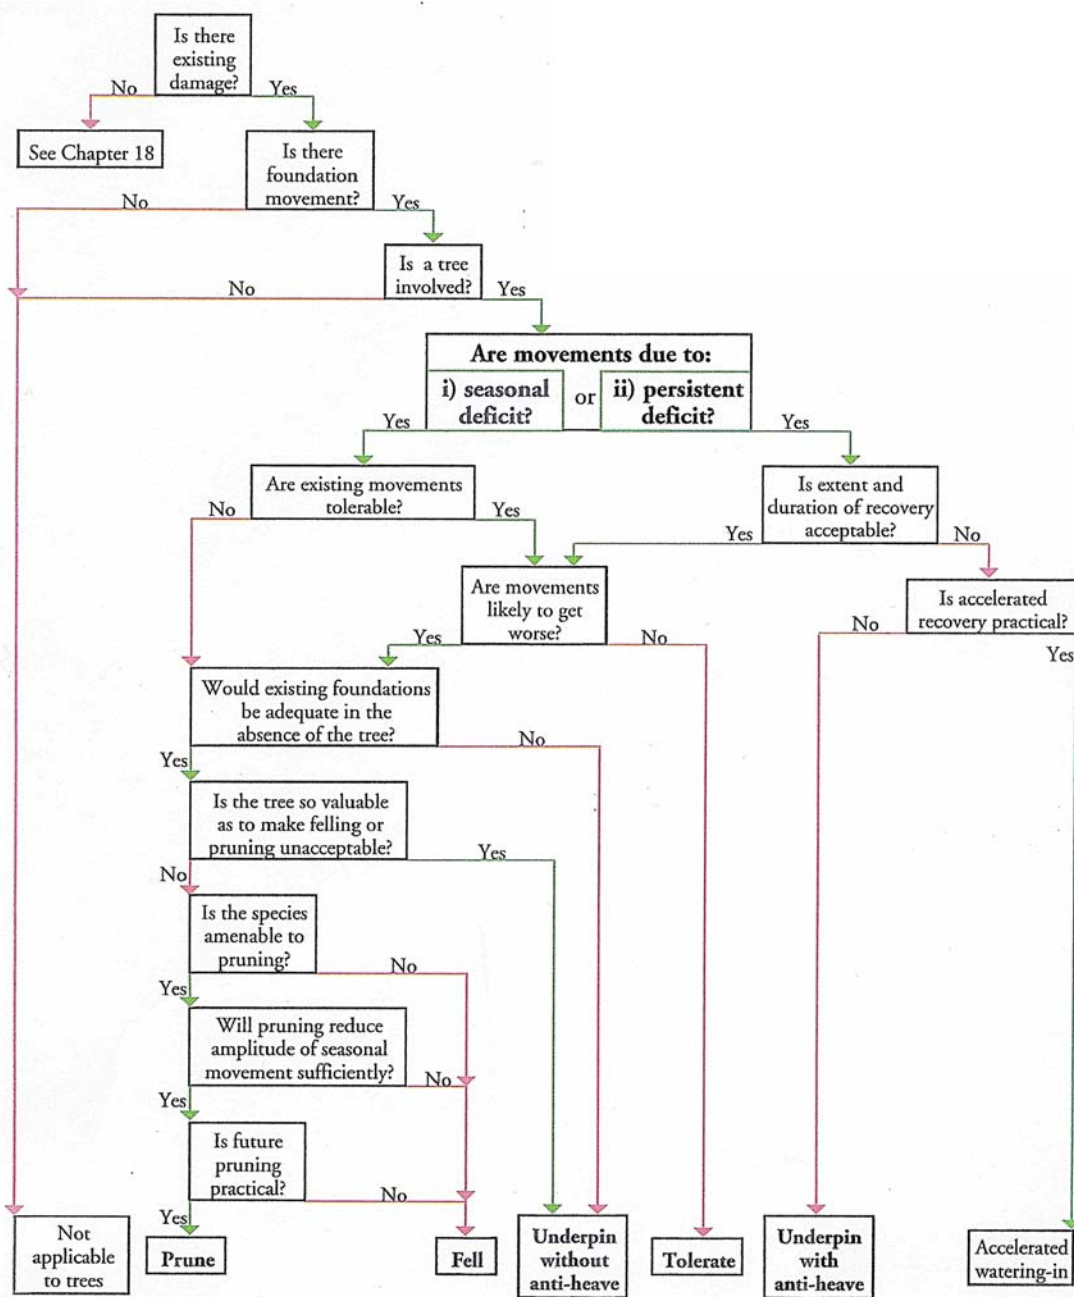
It is important to look into what Dr. Biddle recommends in his widely-cited reference book on trees and buildings (*op.cit.* Reference 1). At the end of Vol.1 (The Choice of Actions pg.295) he gives a very useful flow chart for dealing with a tree-related damage problem which sums up a great deal of what has been discussed throughout the work. This is reproduced below together with a route map through the chart that we supply as an aid to applying it to the present problem as simply and directly as possible. It is evident that his advice to the Council must have been within the constraints of ‘tree management’ i.e. for the cheapest option. But his overall view, as can be seen from his book, would be to underpin the property and not to prune the plane trees.

Is there existing damage? YES.
 Is there foundation movement? YES.
 Is a tree involved? YES.
 Are movements due to seasonal deficit? YES. [there is no persistent deficit under the house]
 Are existing movements tolerable? NO.
 Would existing foundations be adequate in the absence of the trees? YES.
Is the tree so valuable as to make felling or pruning unacceptable? YES.
UNDERPIN.

Figure 17.14
 Decision flowchart for remedial works
